Kinetic Fountain, Beetham Plaza

Prepared for Merseyside Civic Society

Date: 22/06/2023

Rev. 01

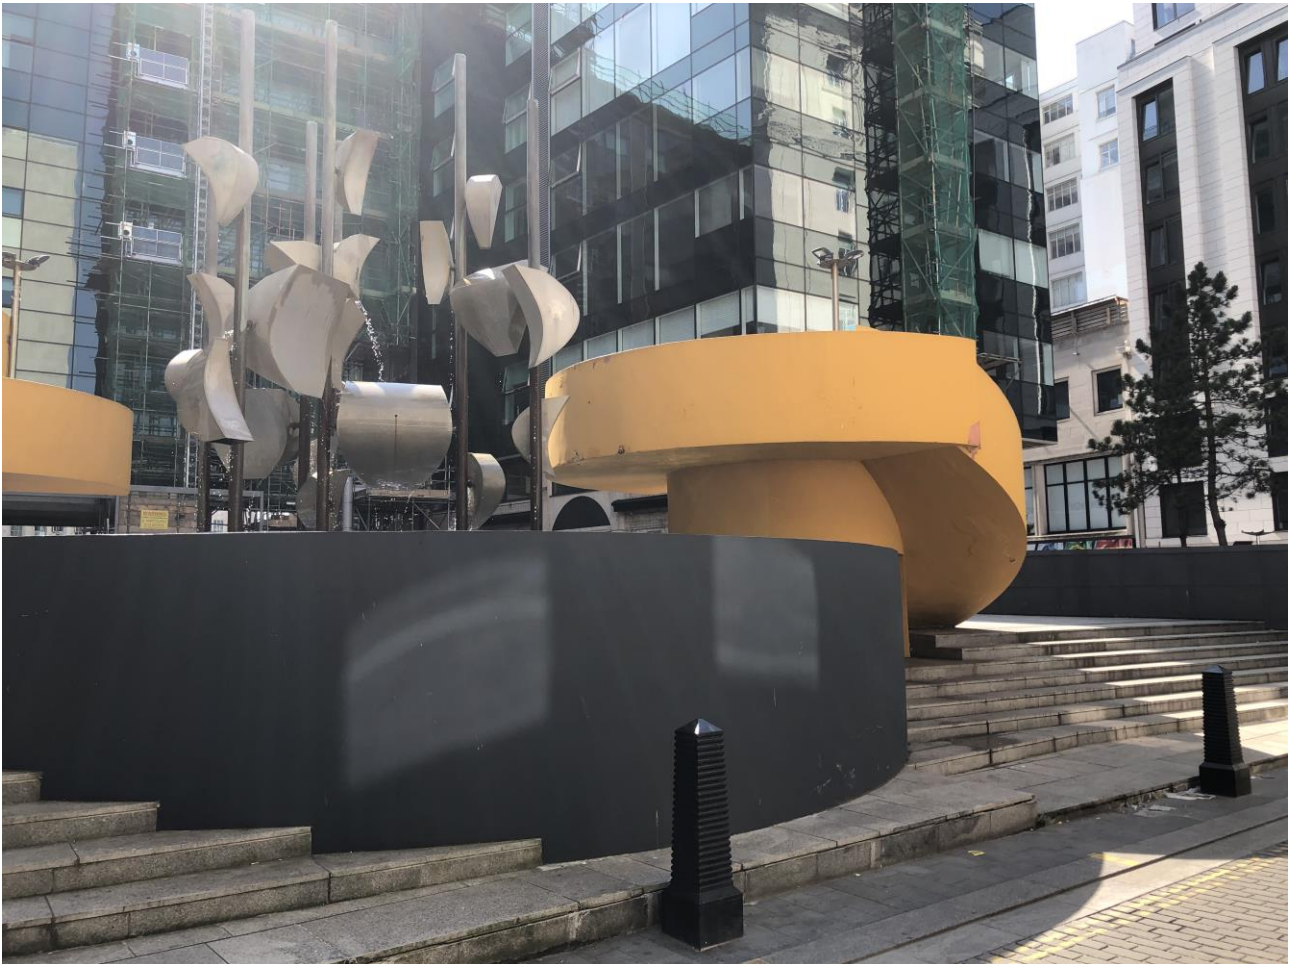
The pool wall is approximately 1.5 m in height where it abuts Drury Lane (Photo 1). The face of the pool wall is rendered and painted.

Photograph No. 1 - View of pool wall from Drury Lane.

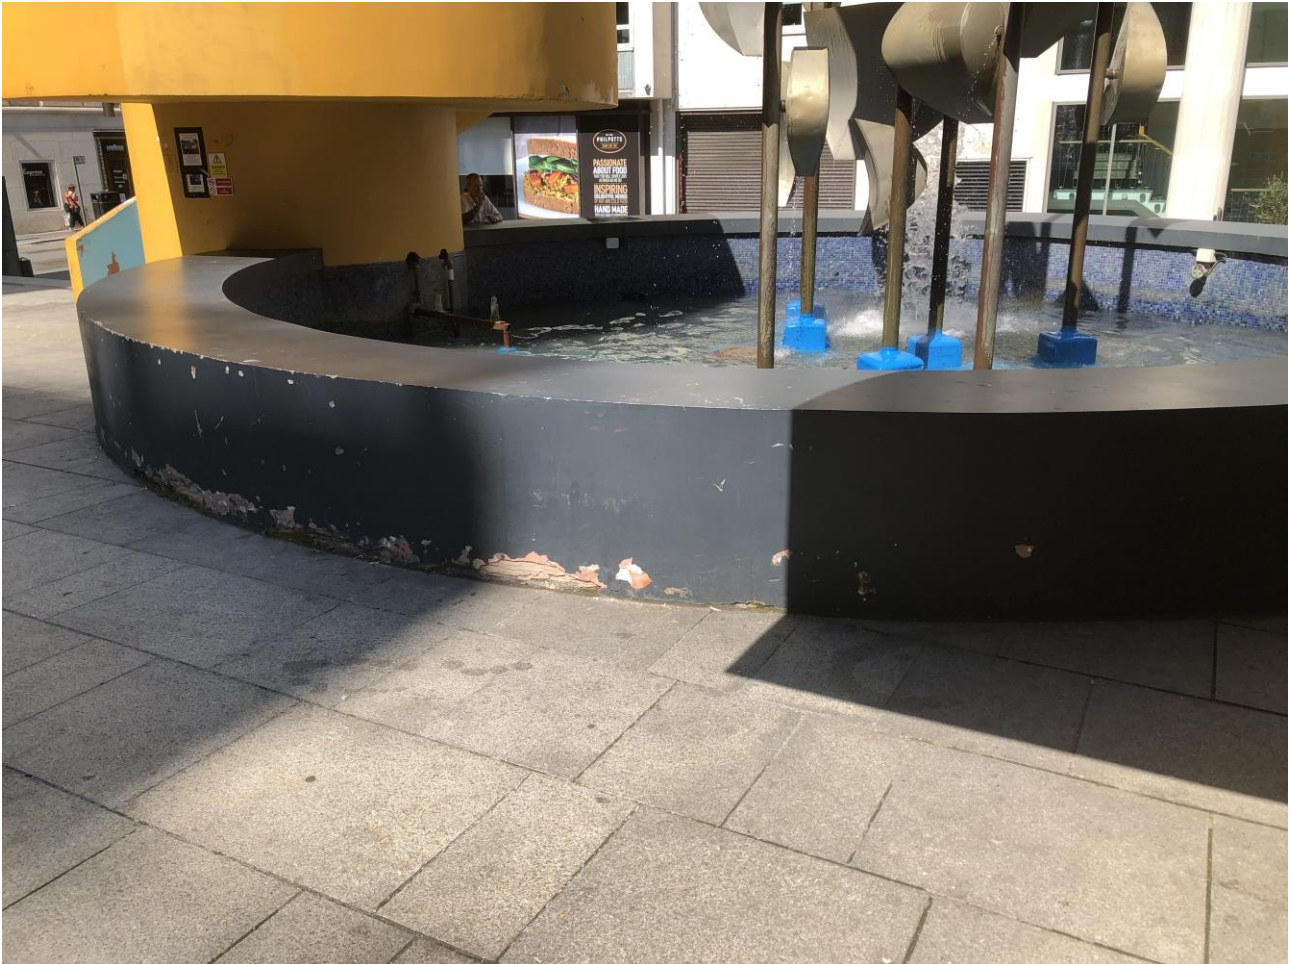
From the plaza level, the height of the wall is approximately 600 mm (Photo 2) and is rendered and painted.

Photograph No. 2 - View of pool from Plaza.

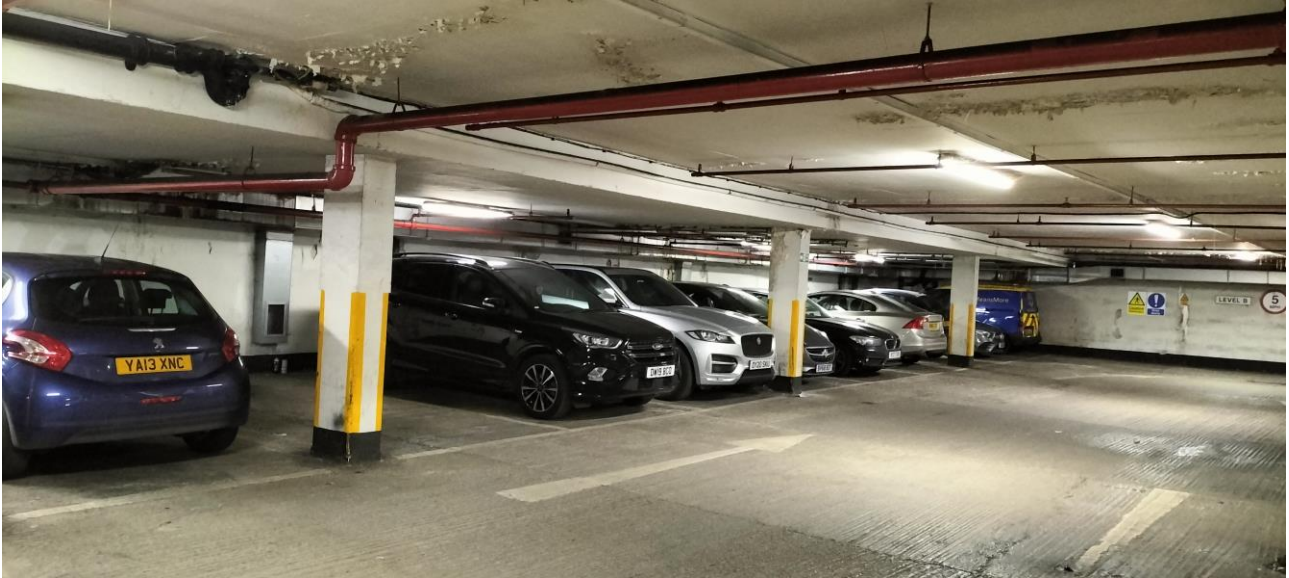
Beneath the plaza within the car park area, there is a line of columns with the underside of the slab at a lower level on the far side, towards Drury Lane (Photo 3). The lower soffit level extends the full width of the car park structure (Photos 4,5 and 6).

Photograph No. 3 – Line of columns within basement.

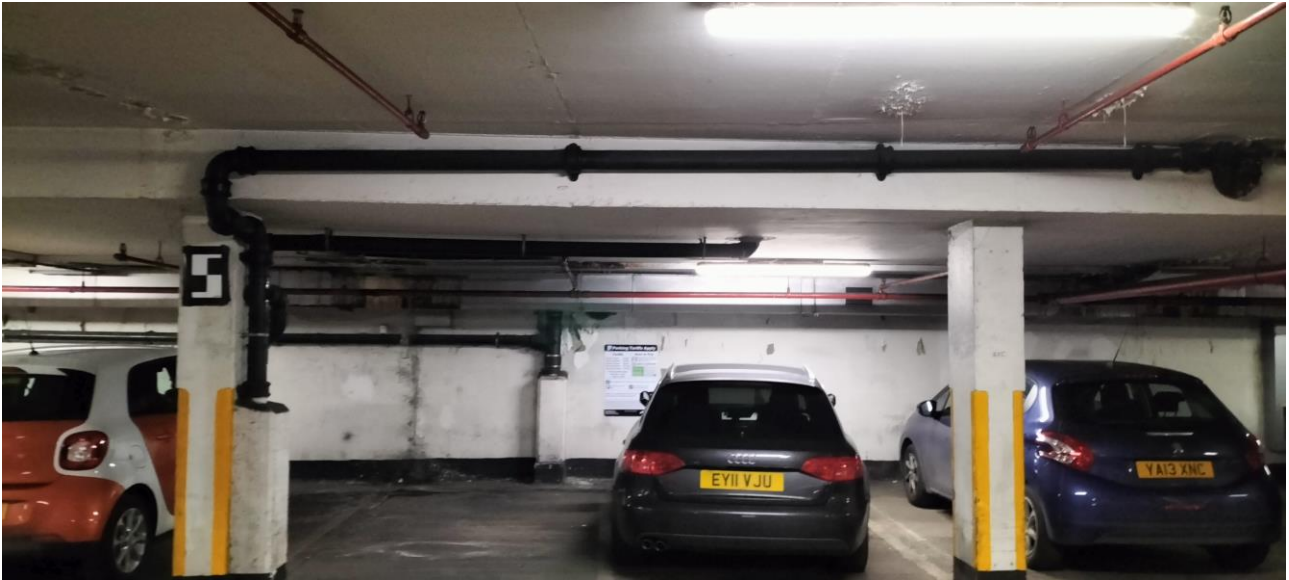
Photograph No. 4 – Lower underside of slab.

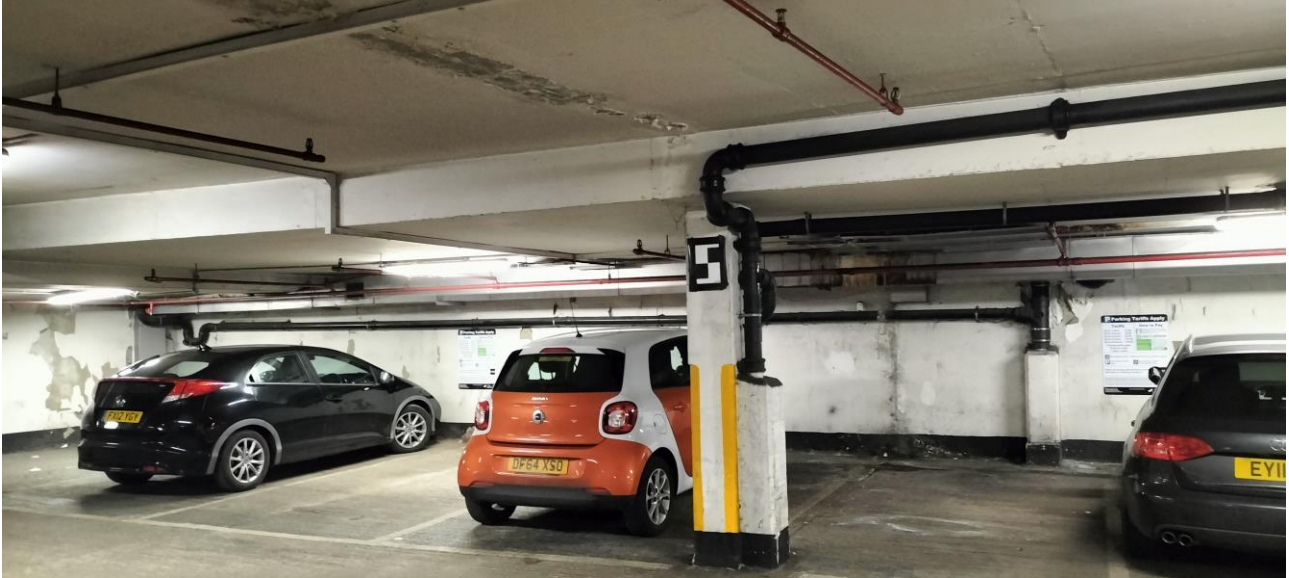
Photograph No. 5 – View within car park.

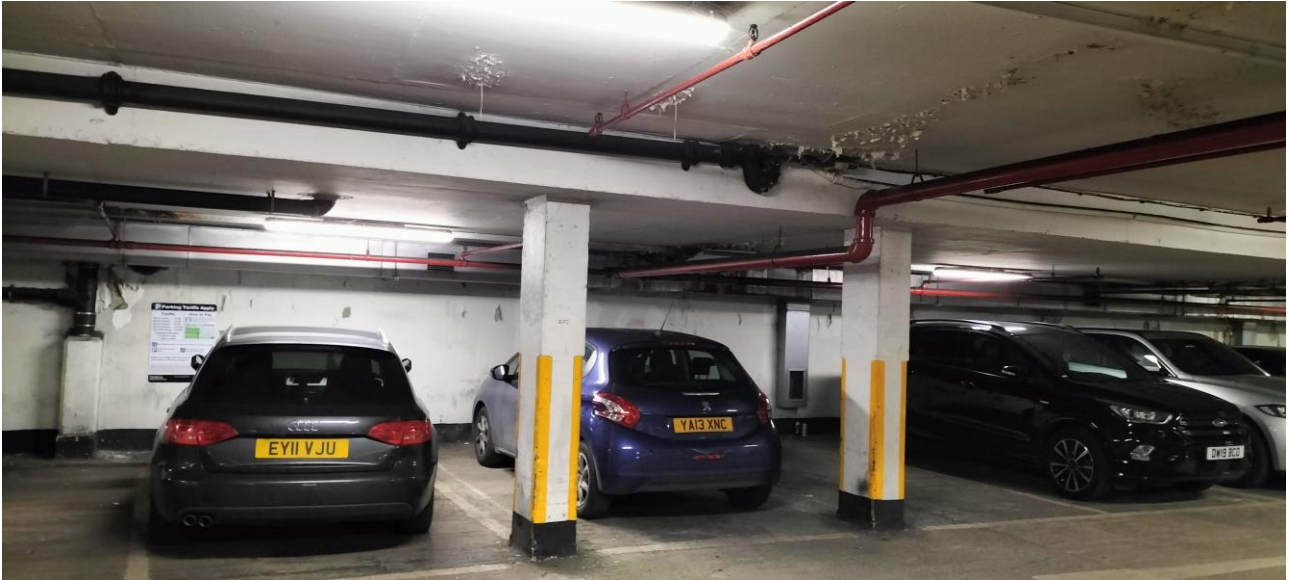
Photograph No. 6 – View within car park.
